Incident Report

Type of event:	Serious incident
Date	28 June 2006
Location:	Nuremberg
Type of flight:	Public transport
Manufacturer / type:	Embraer Empresa Brasileira De Aeronautica / EMB-145LU
Injuries:	Four people slightly injured
Damage:	Aircraft slightly damaged
Incidental damage:	crop damage
Information source:	BFU investigation
Incident number::	5X008-0/06

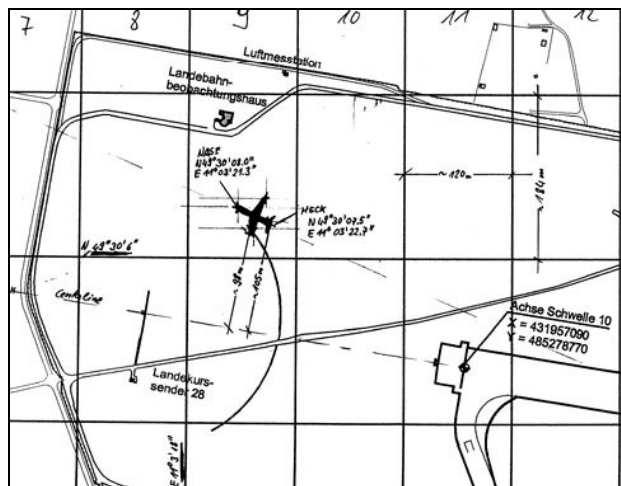
The approach was carried out with the autopilot engaged. The aircraft was on the localiser only and not stabilized on the glideslope, and so the descent profile was very unstable. At a height of about 1,500 ft during the approach the autopilot was disconnected and the aircraft was landed manually. At the time of landing it was raining. According to the crew the runway was partially covered with water and after touchdown no significant deceleration could be felt. The aircraft rolled off the right side of the runway end at high speed and came to a rest 120 m beyond the 10 threshold and about 100 m to the right of the centreline.

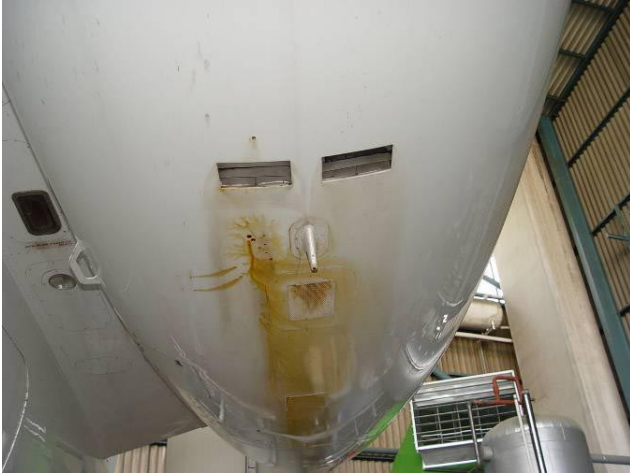
The aircraft overran the end of the runway by about 120 m and came to a rest about 100 m right of the centreline. The ground was firm and therefore the landing gear was not damaged. The beacon light under the fuselage was smashed when the aircraft ran over an approach light. Engine oil was leaking from the left engine cowling.

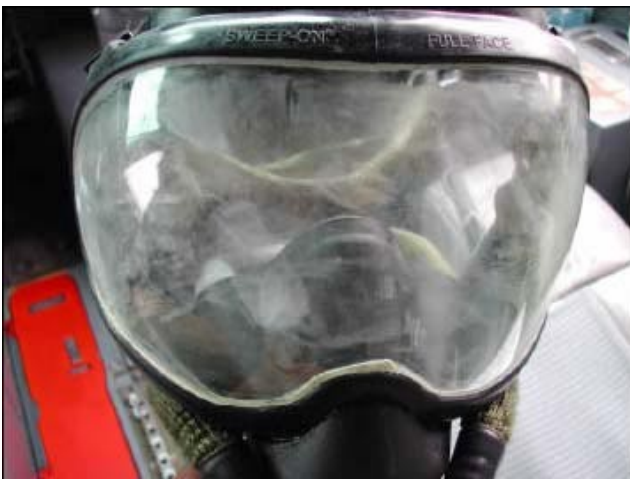
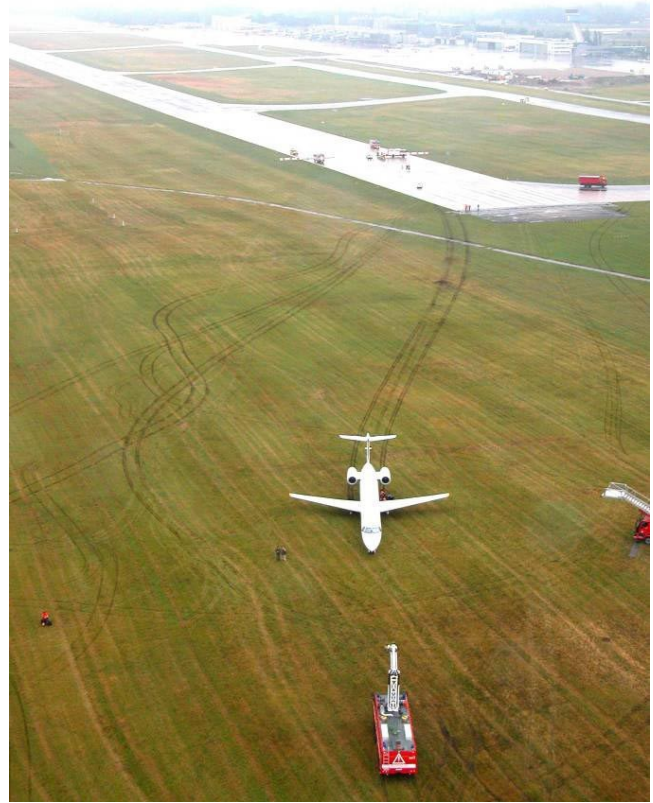
On inspecting the cockpit, it was found that the lenses of the two oxygen masks were heavily fogged and therefore the view of the pilots would have been seriously impaired.
